SERVICING SYLVANIA "HALOLIGHT"

This unique device can be serviced easily and quickly if you know how it works and what is likely to go wrong.

By **GEORGE C. CHERNISH**
Sylvania Electric Products Inc.

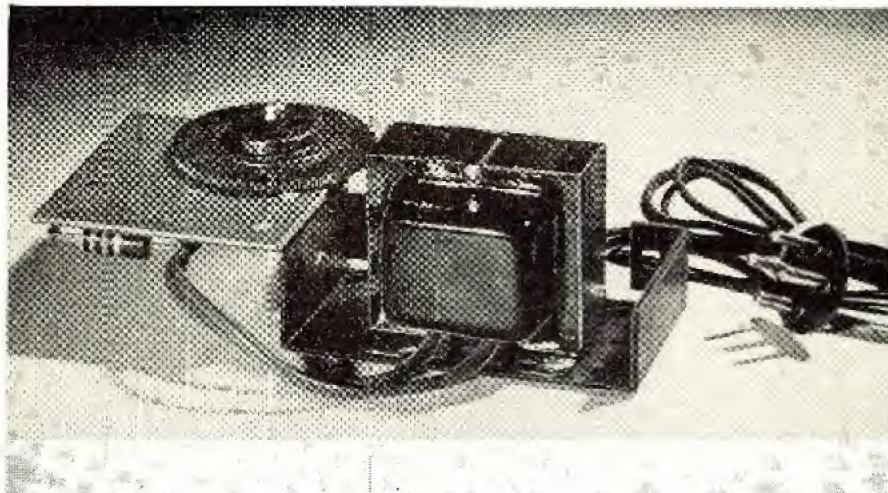
Fig. 3. The various electrical components of the "HaloLight" feature are shown here.

If a lamp will not light, measure the voltage fed to its supply leads from the special socket in the power unit. Fig. 3 shows a "HaloLight" power unit, containing transformer, brightness control, and current-limiting resistors. If a potential of approximately
